## **Executive Summary**

### **Damage Survey Findings**

**Wyndham Partners  
September 8, 2004**

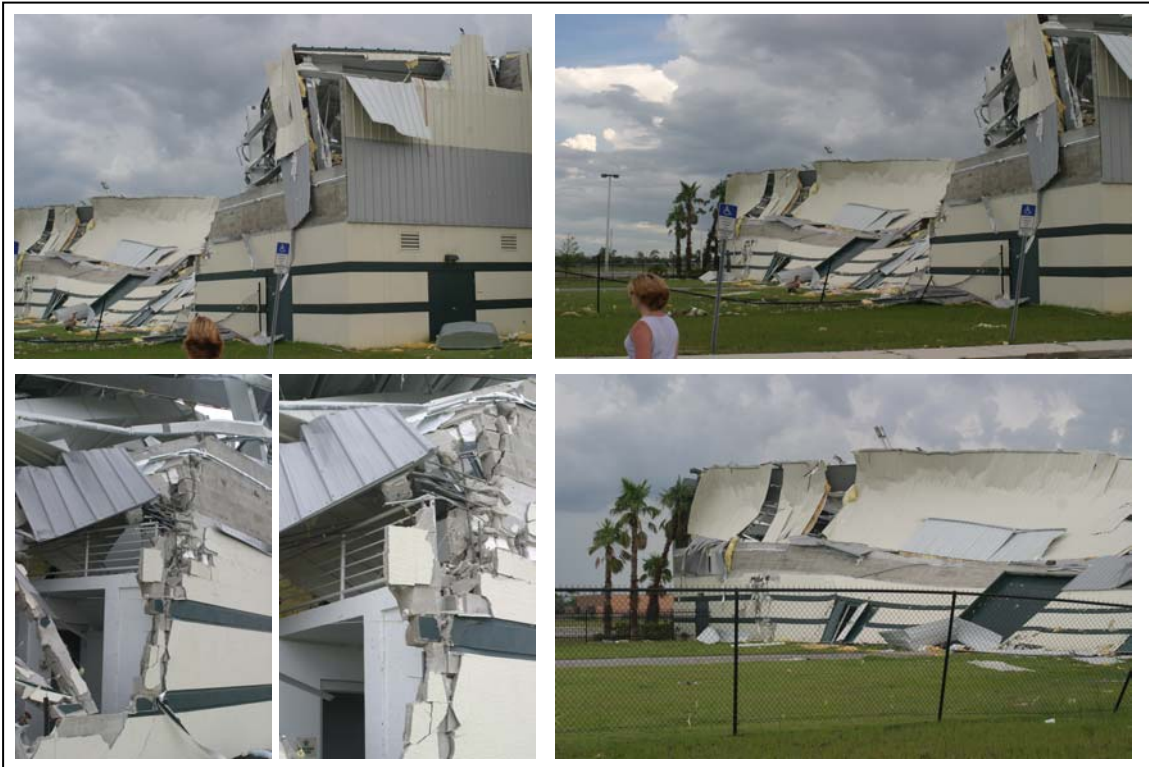
The pictures below show a hybrid building construction with the lower 2/3 constructed from reinforced concrete block with light metal framing on the upper 1/3. The wall failure was likely the result of the roof framing lifting from the top wall plate, which caused the wall to lose its lateral support. According to eye witnesses, the roof began disengaging on the south east corner. As the opening grew, the wall likely lost lateral support at the top. This resulted in the wall framing being unable to sustain the lateral wind loads and progressive collapse began. There also appeared to be some inadequacy related to rebar anchorage within the wall structure, which may have exacerbated the severity of the collapse. This building was used as the Arcadia Community Center. It was 1.5 years old and used as a hurricane shelter during the storm. Some 1300 persons were inside the building as it began to collapse at the height of the storm.

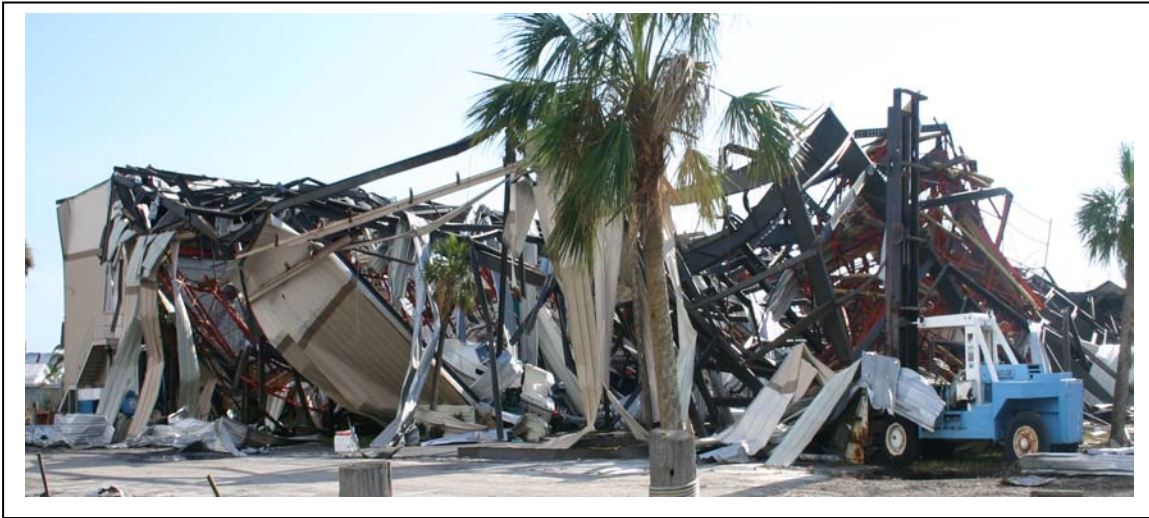
The collapse of this light metal building was likely the result of lost lateral support from damage to the metal sheathing envelope. The building was used as a boat storage hangar and had a great deal of boat mass supported throughout the building height. Once the lateral support weakened, the frame was free to sway off center with the mass from the suspended boats sustaining the lateral motion until the structure collapsed. Content losses were likely in the millions. Also the lateral support was mostly provided by a concrete shear wall located at the left end of the building. The right portion of the building where the collapse initiated had much less lateral support.

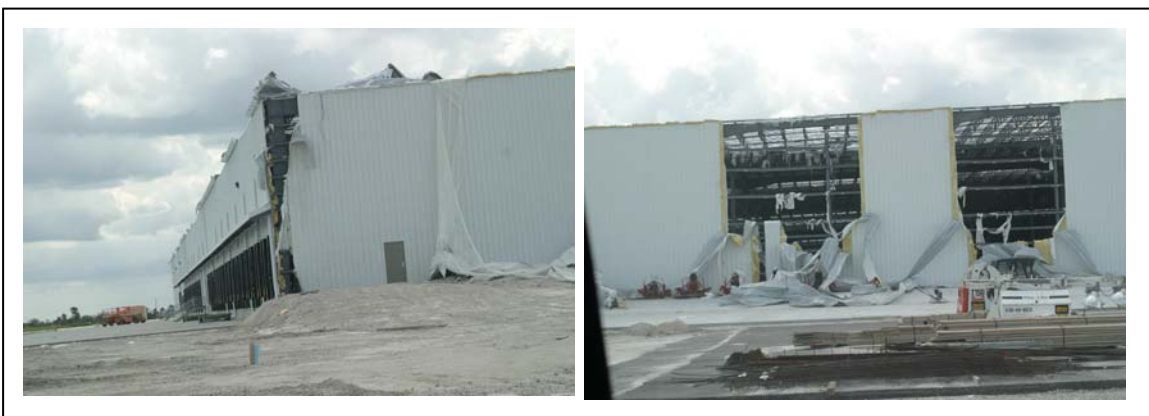
The following failure mode is more typical of light metal building damage. Notice the high corner suction zone damage on the left hand picture. It also shows where roof sheathing began to peel away. It is clear that the mechanical attachment methods used were not sufficient for these high suction zones. The right hand picture shows damage to the leeward wall where negative pressures pulled metal sheathing away from the structure. We can also see that severe damage was sustained to the standing seam metal roof (daylight can be seen through the roof). Although this building was under construction, the area shown in the photograph was reportedly completed before the storm.

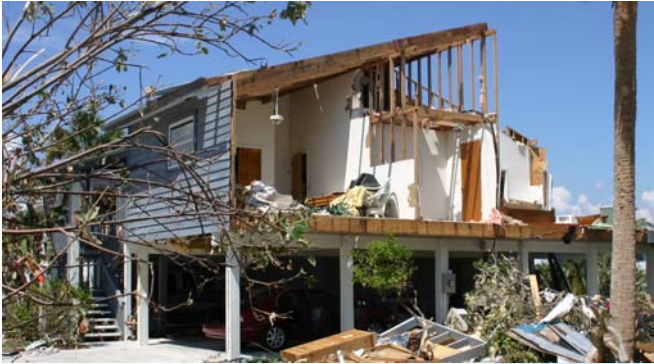
Pre-1994 Construction

These homes are within 200 Yards of each other and experienced the same wind field but performed substantially different based on construction practices.

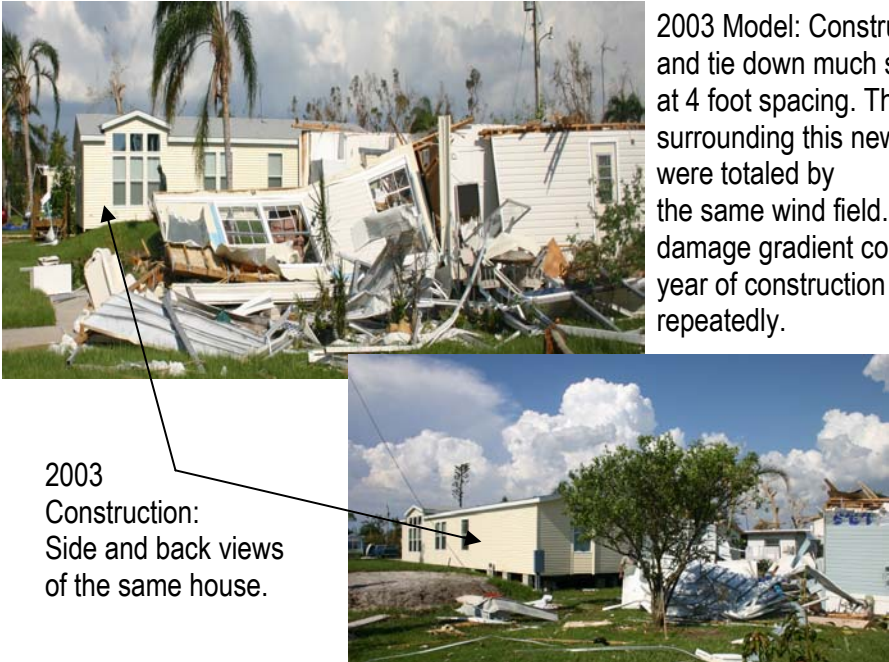
2003 Model: Construction and tie down much superior at 4 foot spacing. The three homes surrounding this newer construction were totaled by the same wind field. This type of damage gradient conditional to year of construction was observed repeatedly.

2003 Construction: Side and back views of the same house.

Typical mobile home damage field – The surviving unit is later construction.

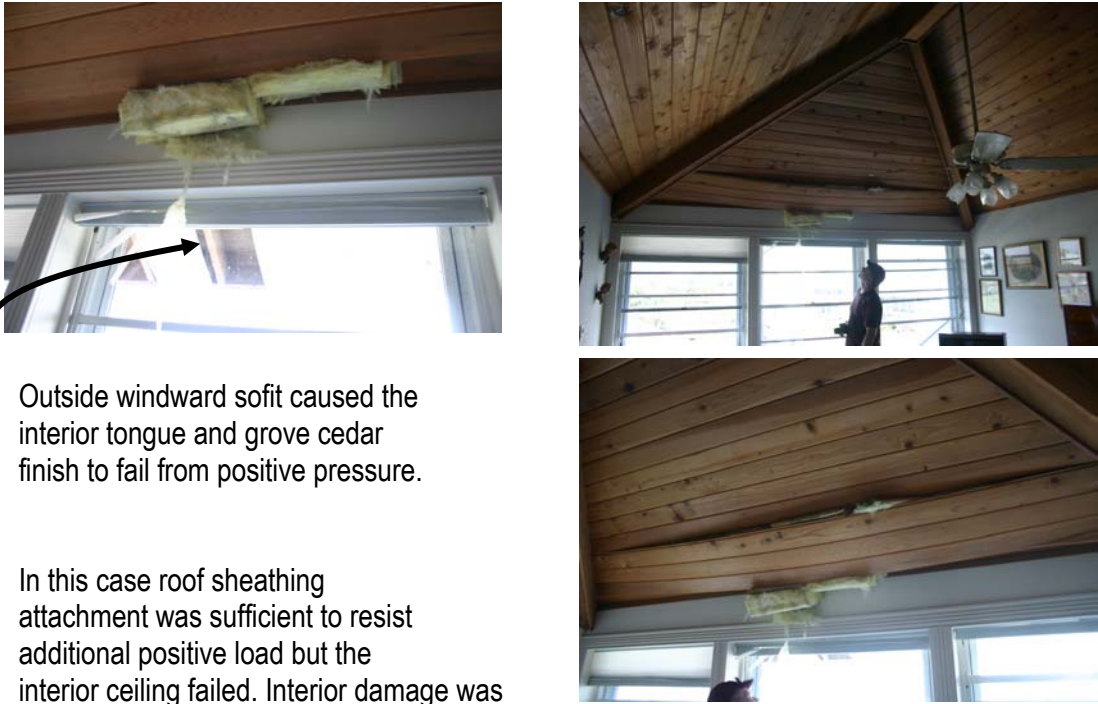
In this case the pressurization on the windward soffit led to a massive progressive failure of leeward sheathing and gable end (no bracing).

Outside windward soffit caused the interior tongue and groove cedar finish to fail from positive pressure.

In this case roof sheathing attachment was sufficient to resist additional positive load but the interior ceiling failed. Interior damage was mitigated only because no gypsum board was used on ceiling finish.

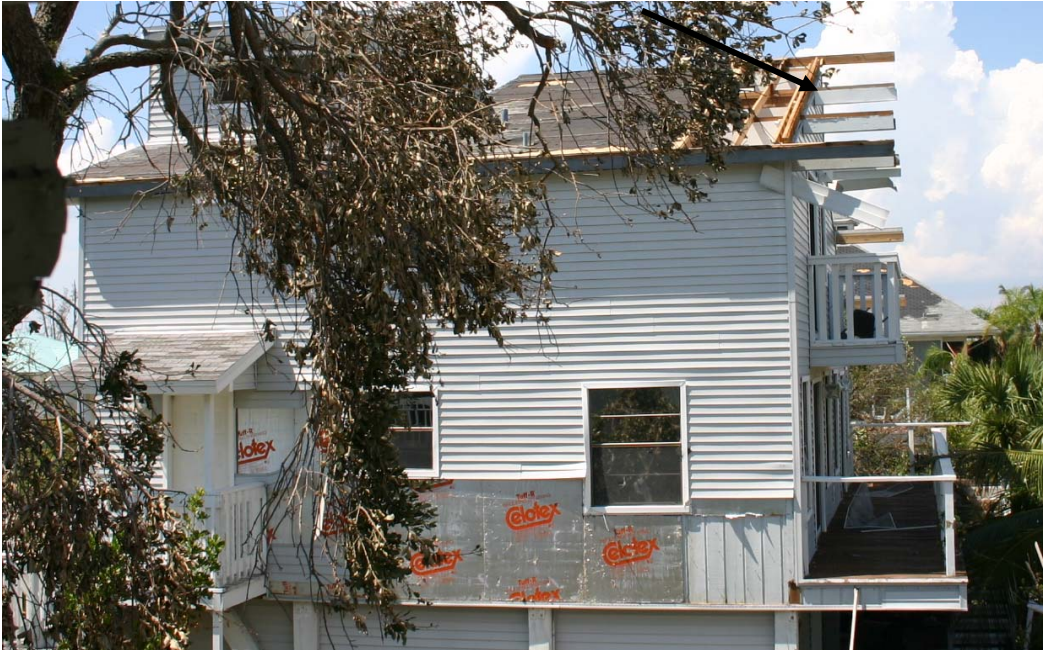
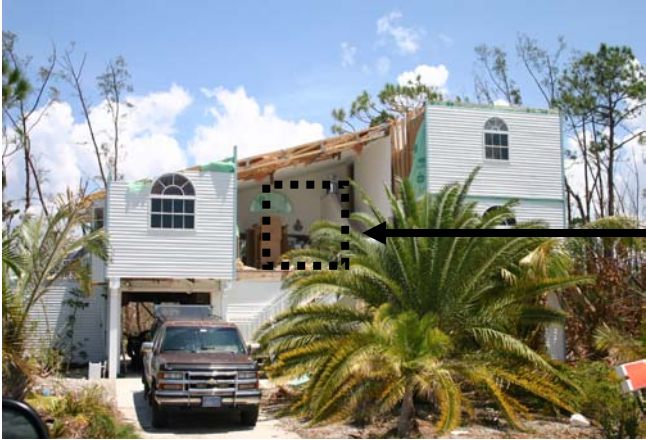
Progressive sheathing failure induced by failure of large overhang.

Large unprotected picture window failed in positive pressure and resulted in massive damage to this home. These types of architectural features are typically installed by local carpenters and may not meet code wind loads.

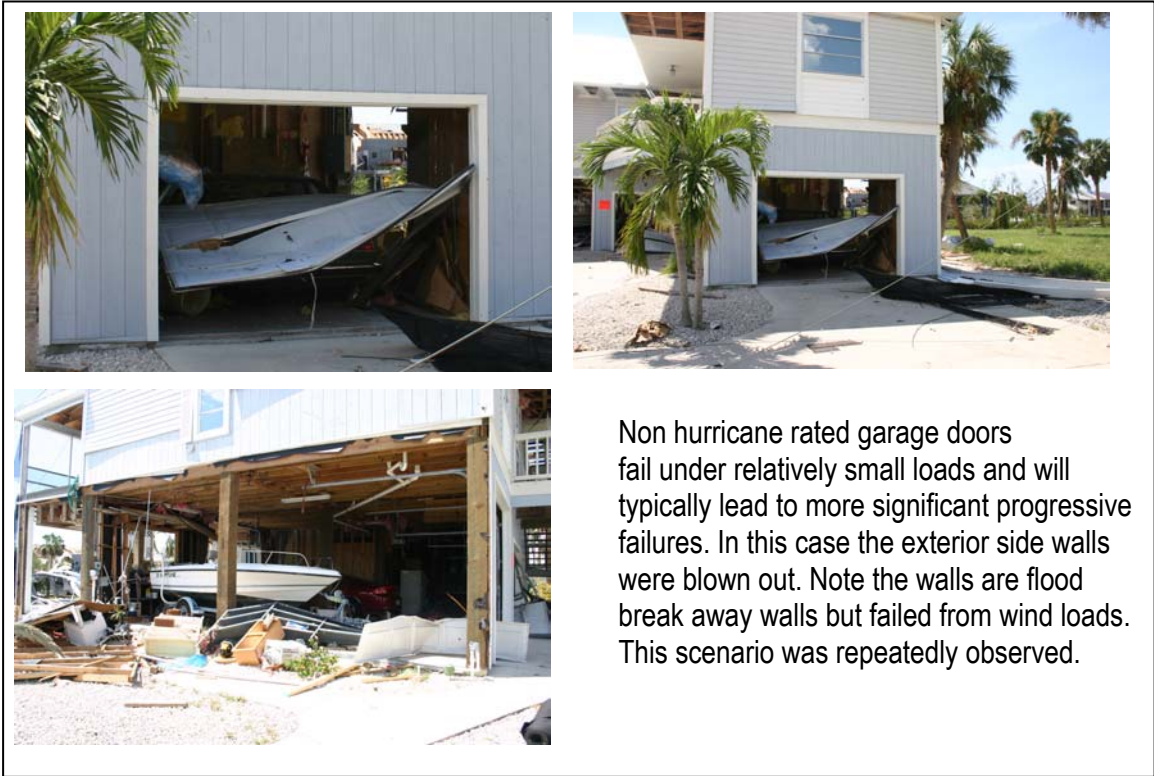
Non hurricane rated garage doors continue to be a leading cause of progressive failure to both residential and commercial buildings. The majority of garage doors in which we observed failures did not appear to be hurricane rated.

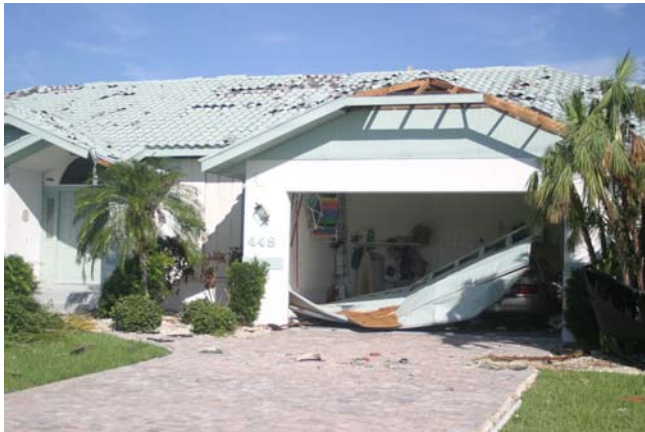
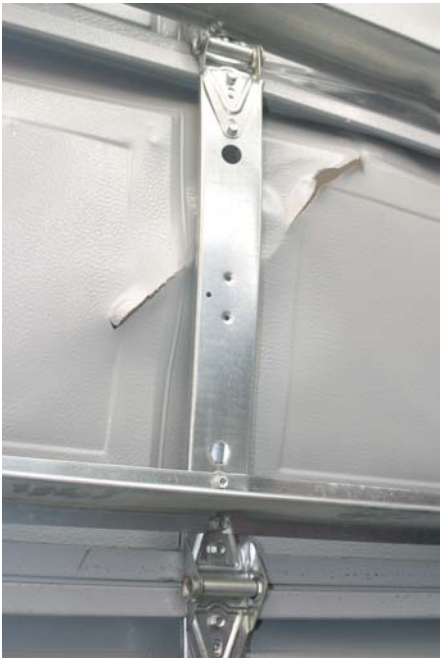
Commercial non-reinforced garage door failures also are common and lead to significant progressive failures.

This building survived internal pressurization resulting from the garage door failing. The skin used in these non hurricane rated doors are vulnerable to wind borne debris impacts.

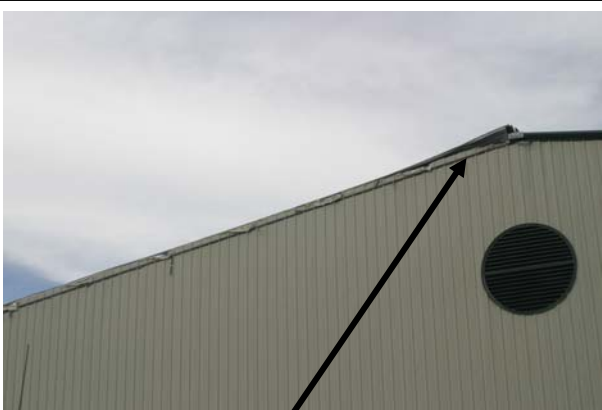
Poor roof edge design continues to contribute to massive peeling failures of single ply and standing seam metal roofs. Current code wind loads are not conservative and exacerbate commercial roof failures. It is estimated that 70-80% of all flat roof peeling failures are initiated at the roof leading edge. Once the roof is compromised, contents are likely to be damaged with business interruption losses likely to follow. A 20% loss to the roof envelope can easily bring content losses towards 50% and initiate BI loss on commercial risks.

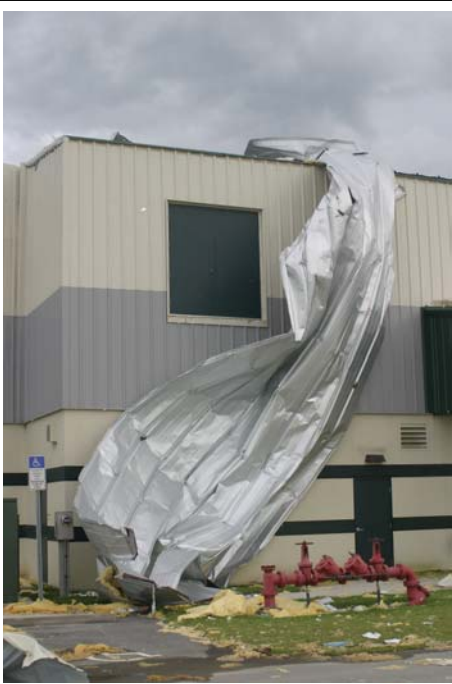
Leading edge failures lead to progressive peeling of the roof membrane.

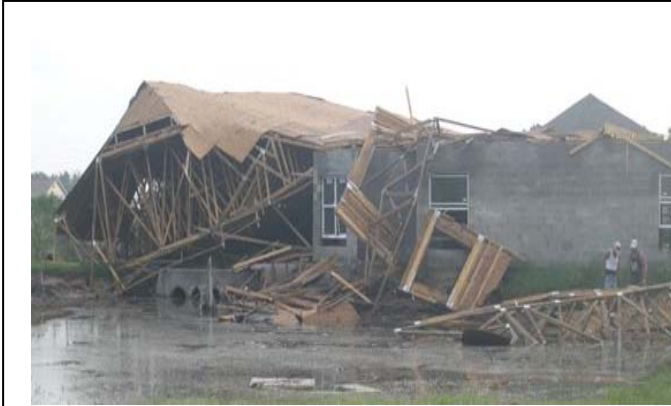
The following is an example where roof tie downs could have been applied during construction to help reduce damage. This example shows a course of construction where the roof system was not tied down immediately following assembly. The damage consisted of the entire roof assembly sliding off the wall top plate and was dramatic. This building was under construction and the roof rafters had not been strapped to the top wall plate prior to the storm.

This roof was not secured to the wall top plate. The surrounding structures did not suffer any damage under identical wind field conditions.

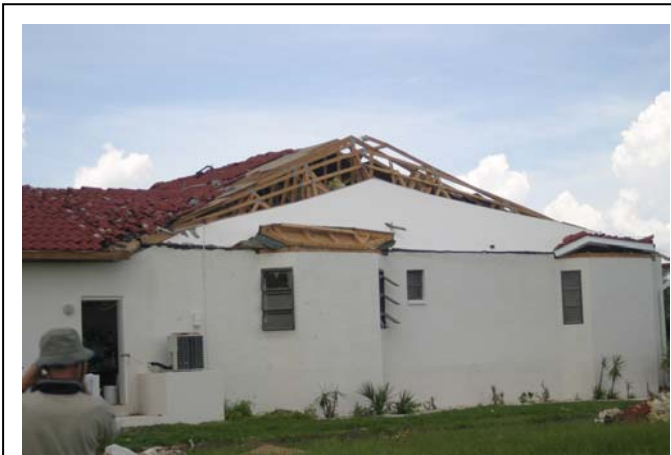
Gable end failures were also common where the gable end was not adequately supported. Gable end failures also occur when the sheathing is lost and lateral support removed.

High suction zones occur near gable ends. These loads likely cause significant sheathing loss.

In this case sheathing loss ultimately led to the gable end failing in positive pressure from reduced lateral support.

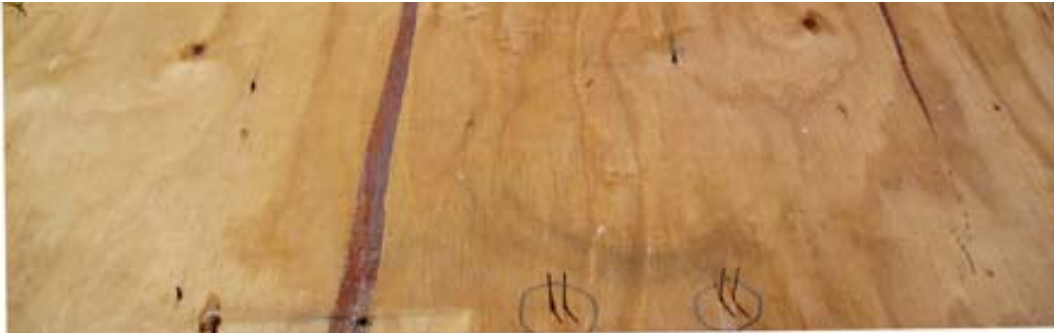
Many sheathing failures were related to staples as the attachment method. The sheathing thickness in these instances was typically 3/8.

Staple attachment – Simply a disaster waiting to happen.

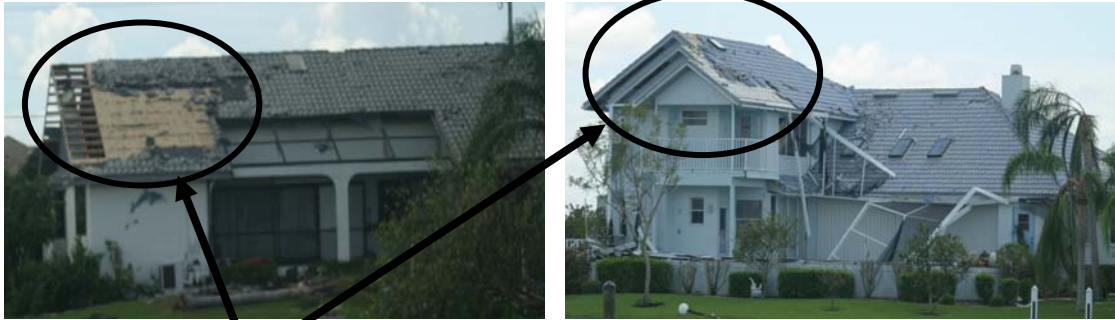
There were many examples of tile and shingle failures in Punta Gorda. In minor cases only a few tiles were lost at the ridgelines (areas of high vortex generation) and in more severe cases large portions of the tile roof were lost. In many subdivisions tiles are often mandated by covenant. Consequently, wind-borne tiles pose a significant threat to neighboring buildings. When missiles breach the building envelop of adjacent buildings, progressive failure may occur from internal pressurization. Tiles set only in a mortar adhesive detached readily to become airborne missiles. Homes with the newer architectural shingles performed significantly better than traditional shingles or tiles adhered with mortar only.

Classical damage pattern to gable end roofing material.

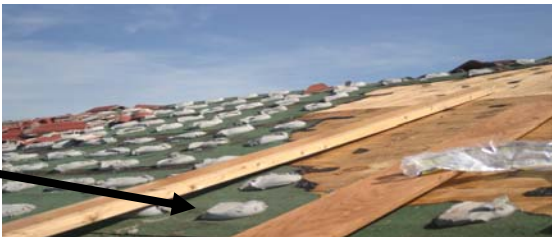
In those instances where tiles have no mechanical attachment but only adhered with mortar failure rates were dramatic.

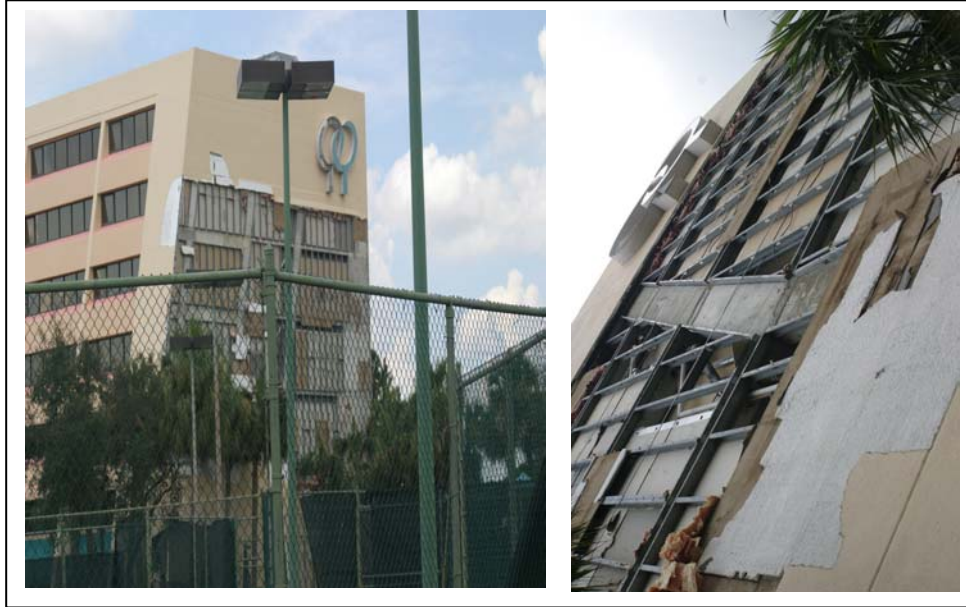
Although this building is reinforced concrete, because it has an EIFS cladding, the true vulnerability may not be taken into account. The building is located near downtown Disney and within the weak wind field of Charley. In this dense area of commercial hotels no adjacent buildings were observed to have suffered noticeable damage.

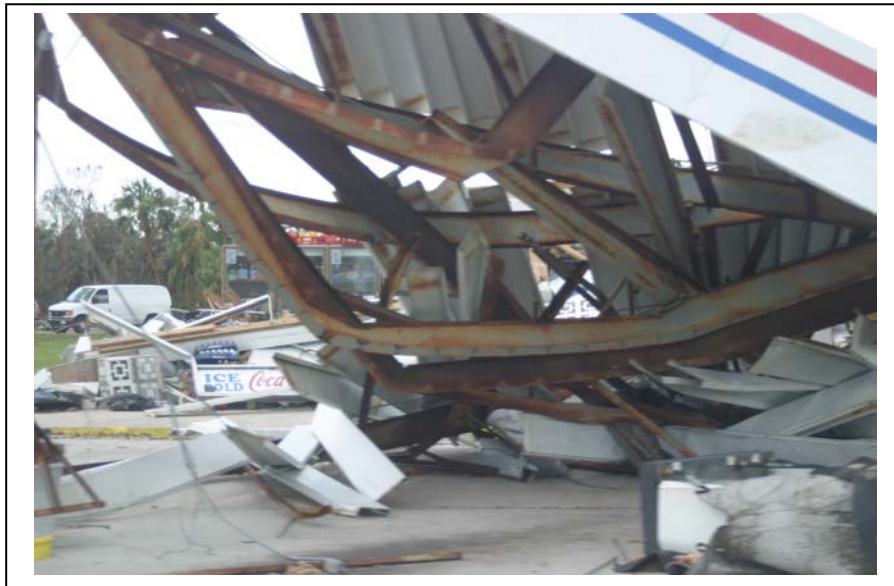
Most commercial signs, billboards and overhead canopies located within the wind field suffered varying amounts of damage. Structural failures were not uncommon, but plastic lettered inserts generally failed at lower wind speeds.

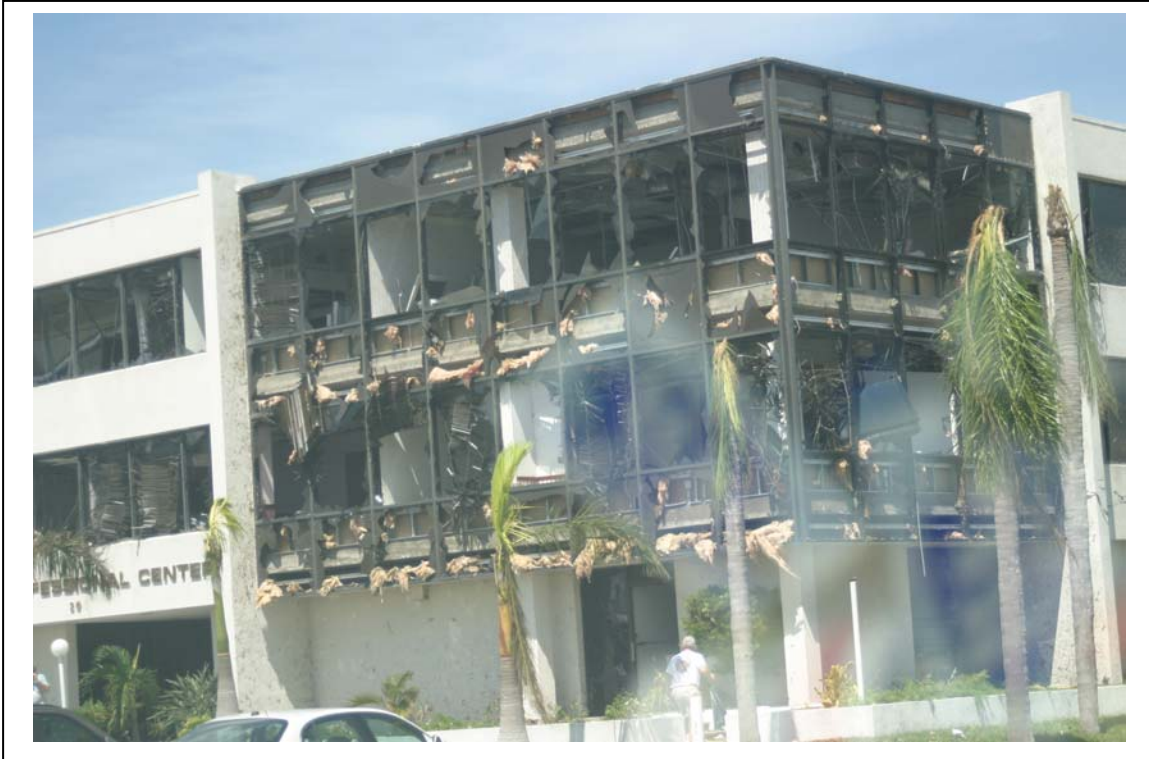
Many small businesses located near missile sources (adjacent buildings with gravel roofs) suffered from broken windows.
